MONUMENT RECORD
State of Indiana - County of Monroe

Corner ID: Polk K-25

RECOVERY TIE DRAWING
Field Book 41 Page No. 41

CERTIFIED LAND CORNER RESTORATION

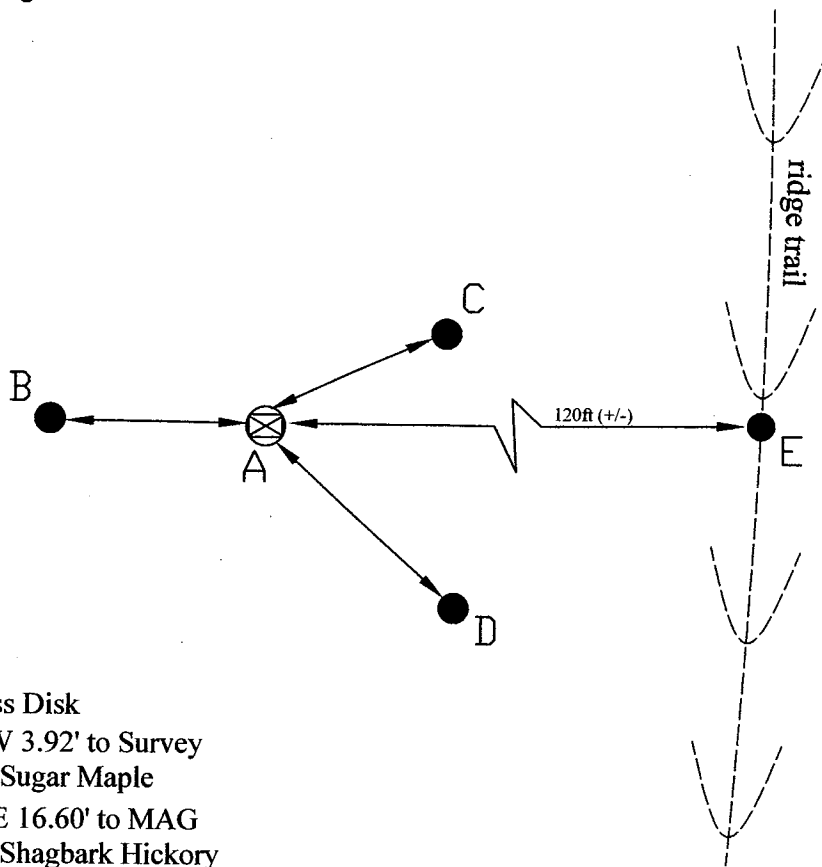
Monument Description & Remarks: 3" Brass Disk stamped, "1/4 S.33 T7N, S.4 T6N, 1973 SO143". Survey Sign 5ft above ground at pt. B

A - 3" Brass Disk

B - S 89° W 3.92' to Survey
Sign on 4" Sugar Maple

C - N 86° E 16.60' to MAG
nail in 14" Shagbark Hickory

D - S 24° E 21.45' to MAG
nail on 6" Shagbark Hickory
